Building Envelope Failures

*Investigating & Diagnosing Water-Related
Damage Claims*

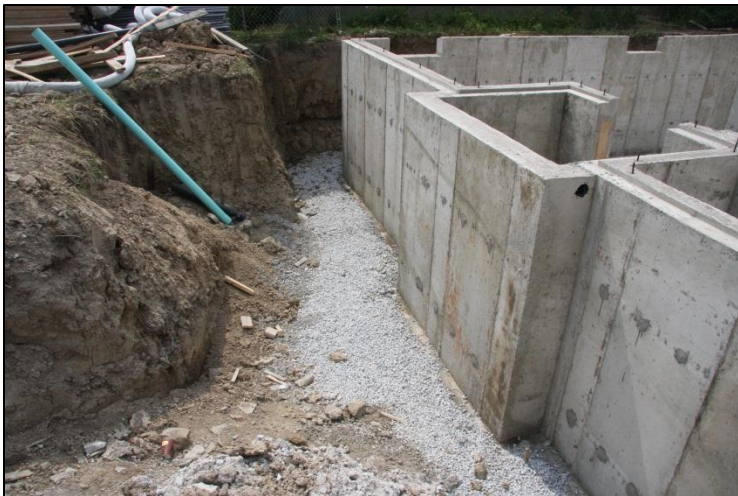
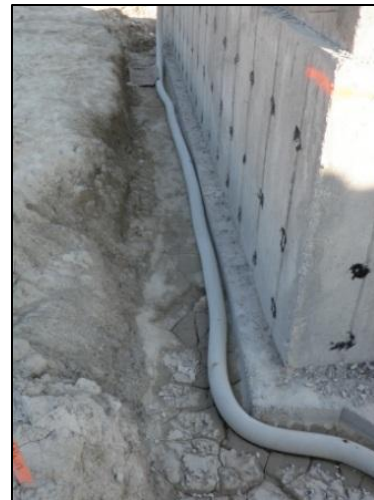
In most of Ontario, foundations are constructed of poured concrete and comprise the footing and basement wall.

A weeping tile system will be laid around the perimeter of the footing typically with a fabric 'sock' to keep debris out and covered in granular stone to facilitate the dispersal of water that may collect at the outside of the footing & wall surface.

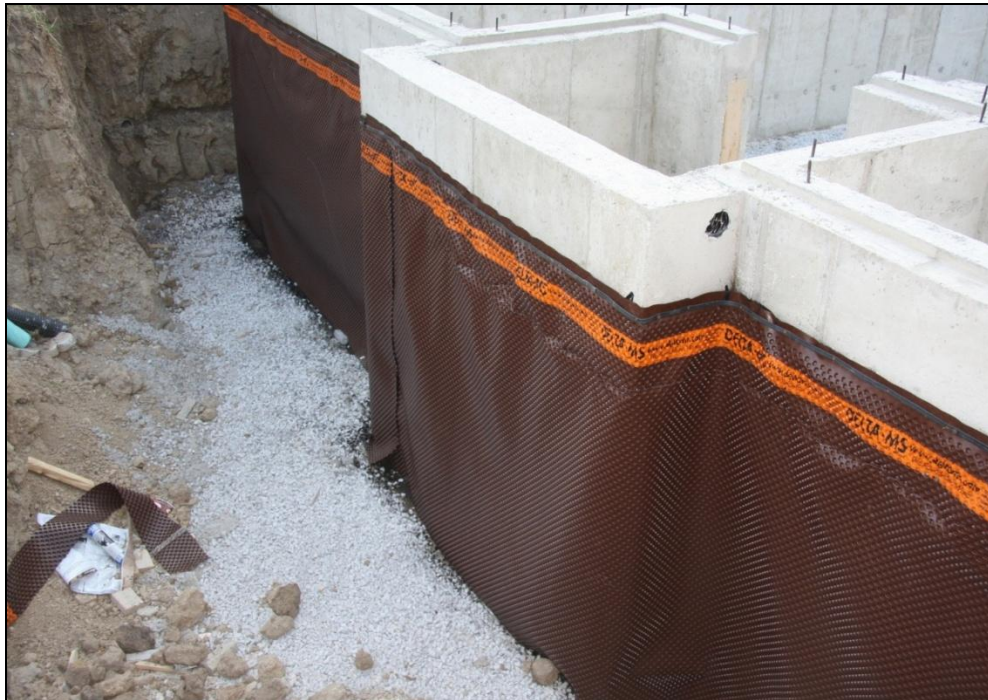
Waterproofing is applied to the exterior surface of the foundation to aid in repelling water.

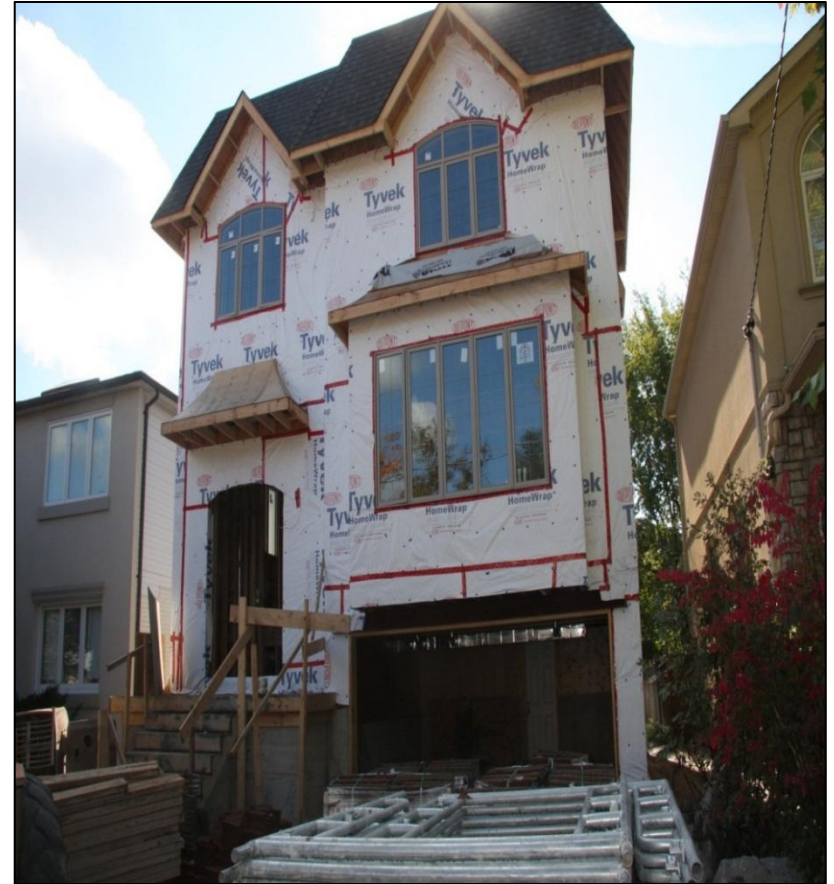
Exterior Wrap

- ❑ Covers Sheathing
- ❑ Tyvek or Similar
- ❑ All Joints Tape Sealed
- ❑ OBC Requirement

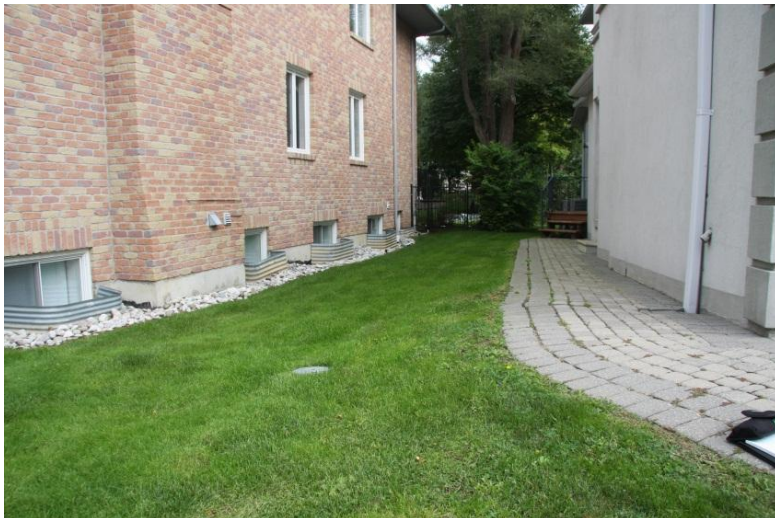
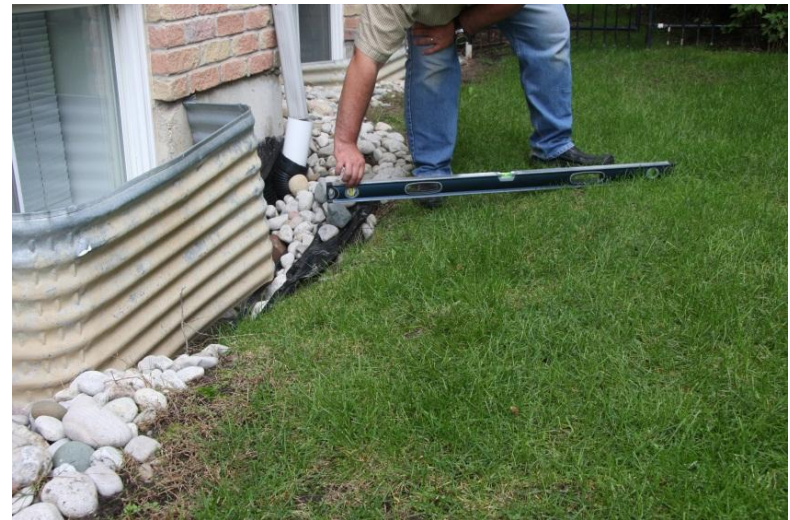
Site Grading

- ❑ Positive Slope Away from Foundation
- ❑ Grade Clearance to Exterior Wall Cladding
- ❑ Drainage Swale to Channel Water Away From Foundation

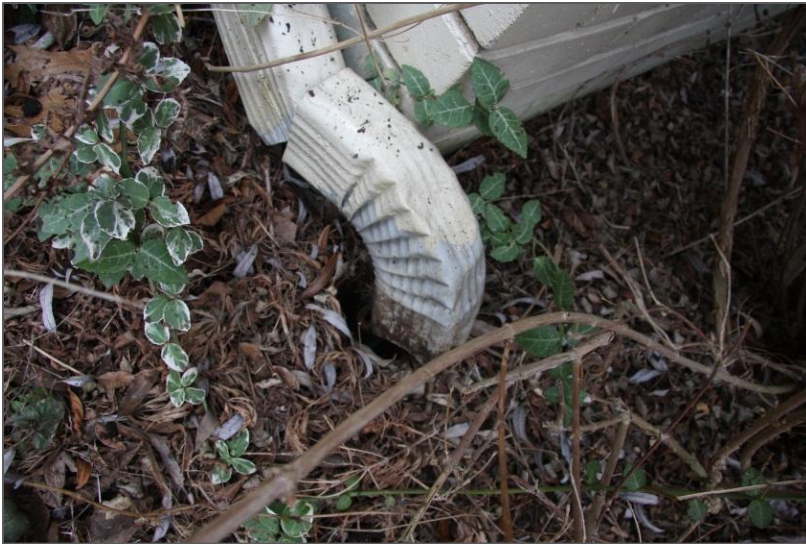
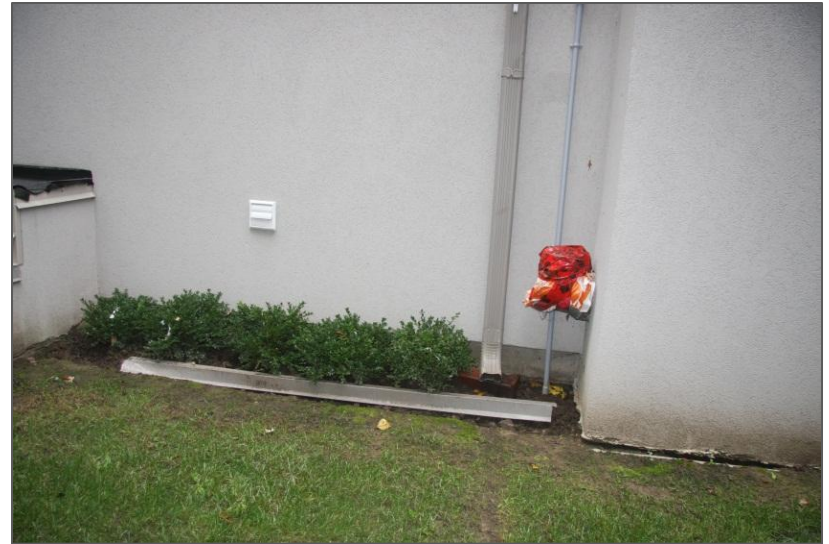
Rain-Water Leaders

- ❑ Confirm if Above or Below Grade
- ❑ Discharge Outlet Location

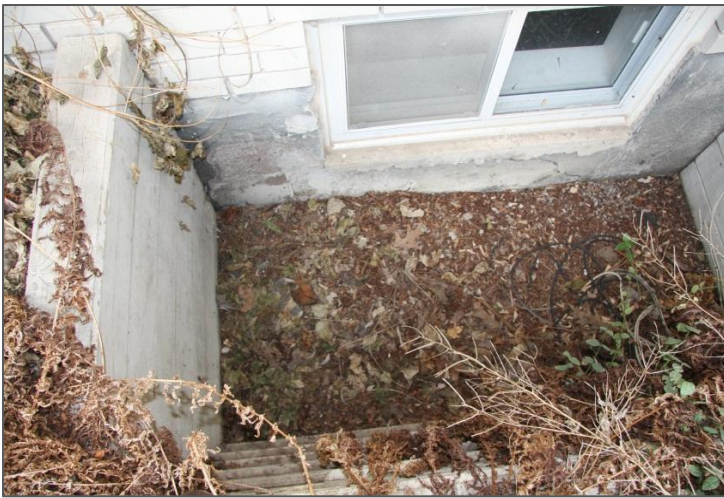
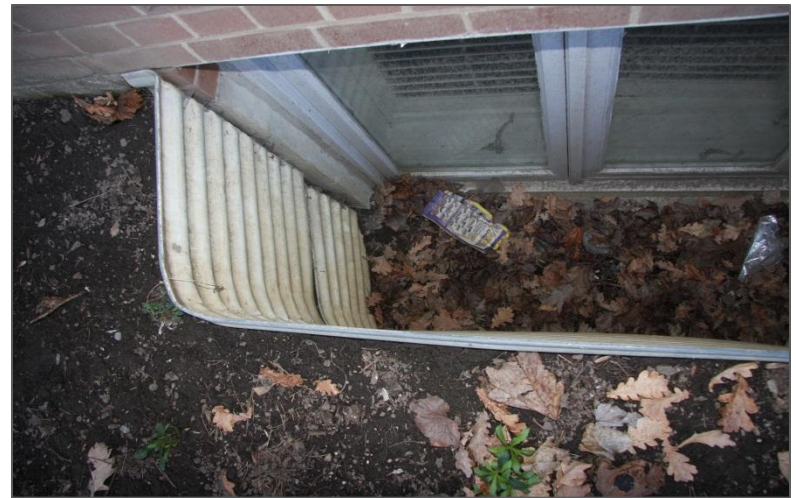
Window Wells

- ❑ Drains Blocked or Missing
- ❑ Clearances Between Windowsill and Grade
- ❑ Preventative Maintenance Practices

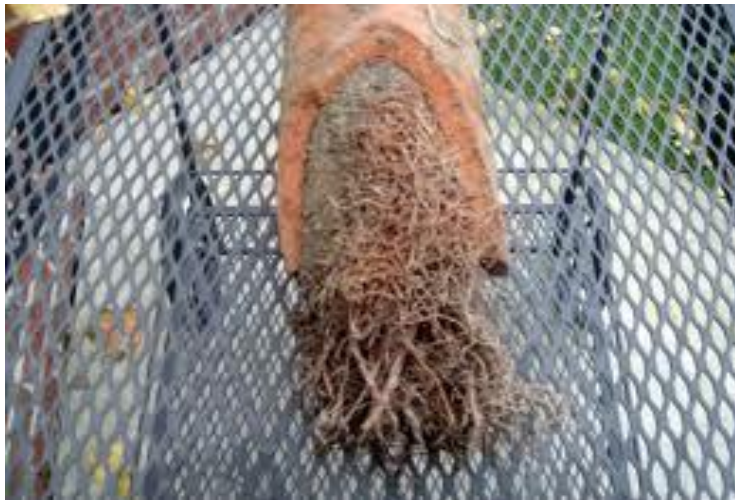
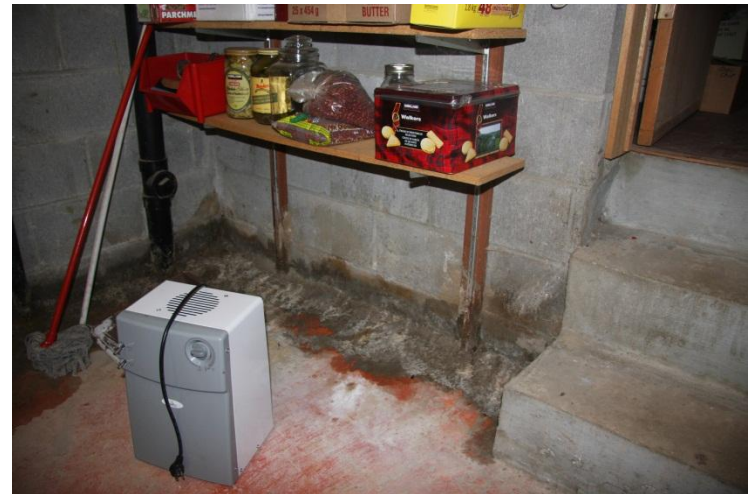
- ❑ Failure of Weeping Tile
- ❑ Failure of Damp-proofing
 - ❑ Slab/Foundation Wall Interface

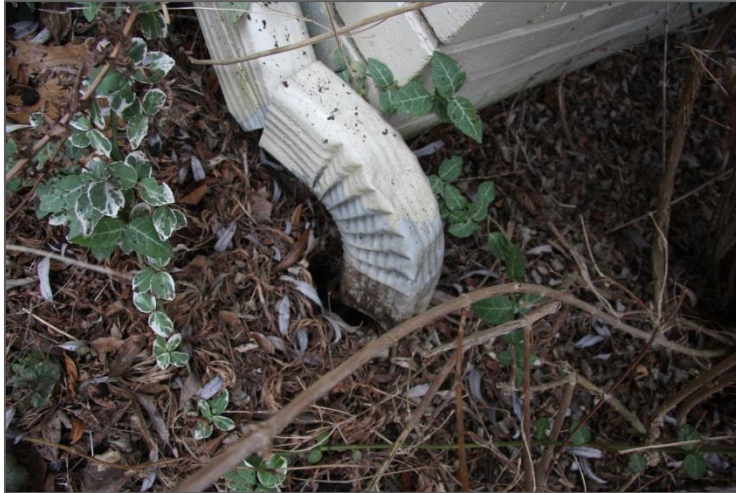
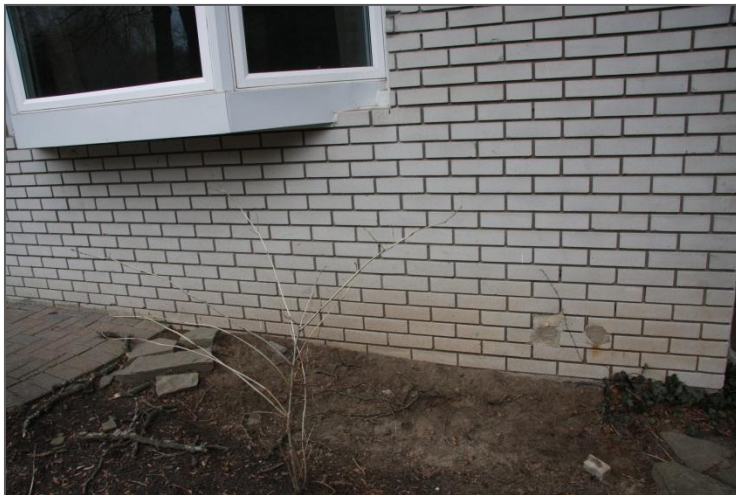
Exterior Verification

- Exterior Site Review
 - Rain-Water Leaders Discharge Point
 - Exterior Grading
 - Consider Age of Dwelling and Construction Practices

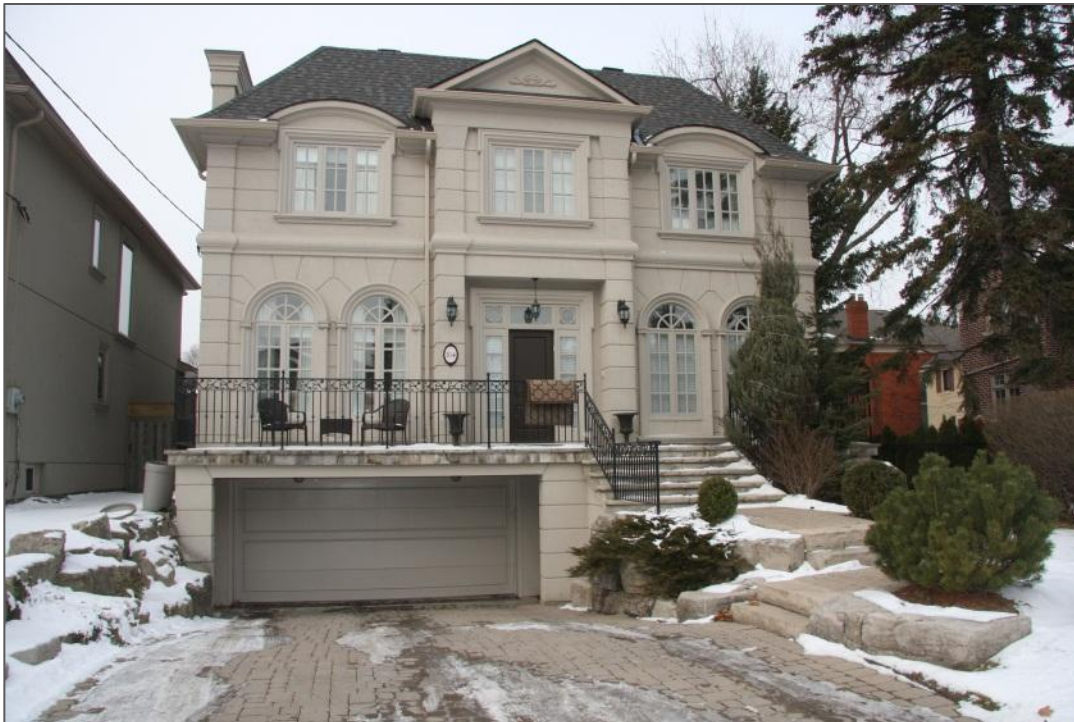
Cladding System Failure Scenario

❑ EIFS Wall System

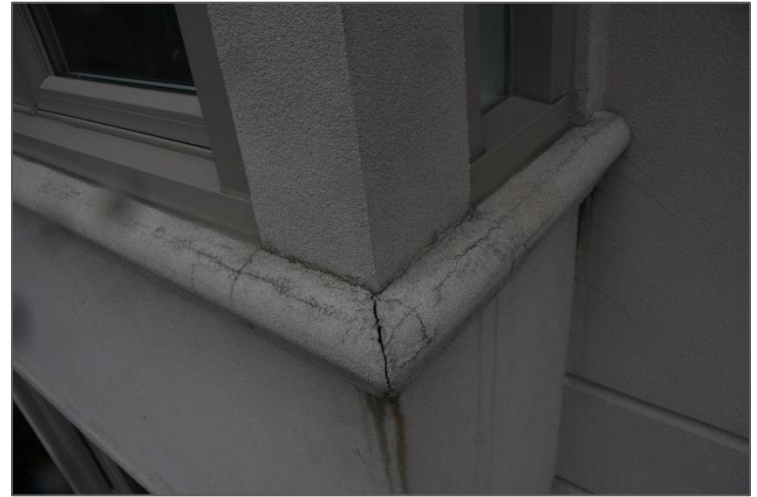
Cracks in EIFS Wall System
Caulking Missing or Cracked

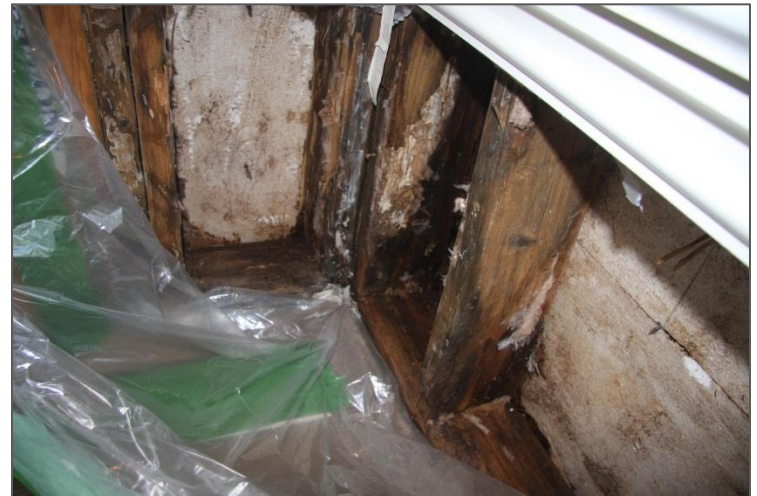
Direct Moisture Entry into
Wall Cavity

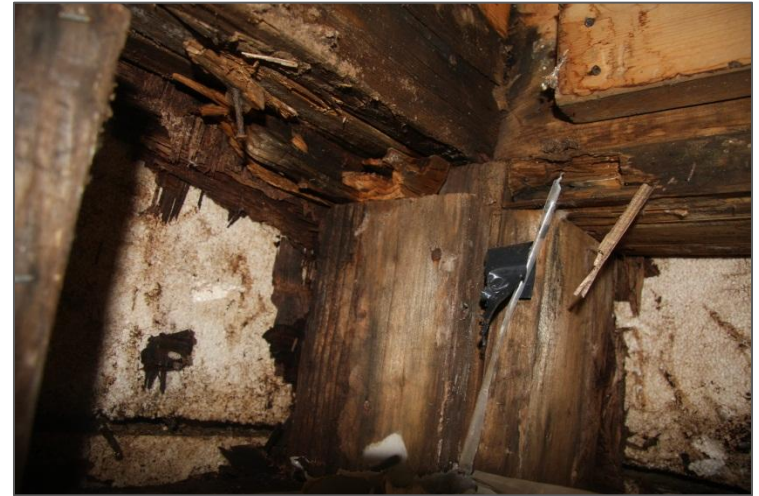
Structural Decay and Rotting of
Wood Framing

Exterior Sheathing Deteriorated

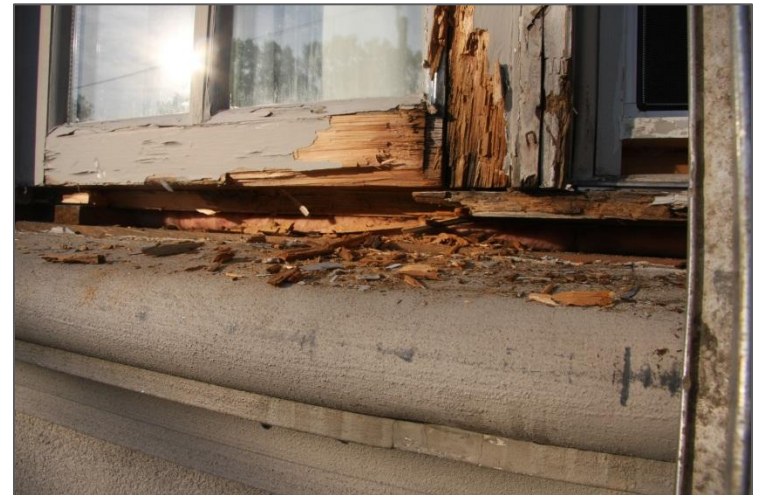
Wood Window Frame
Deteriorated Due to Lack of
Maintenance and Repair

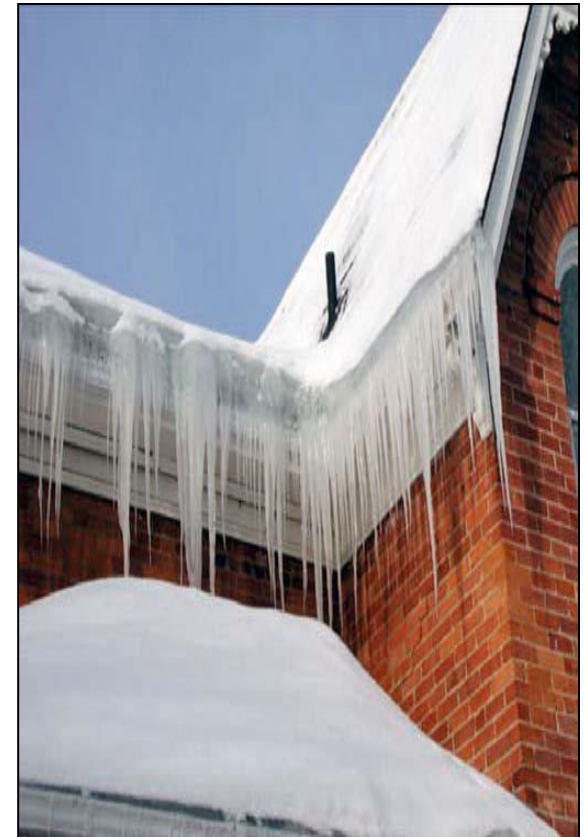
Ice Damming Conditions

- ❑ Lack of Ventilation in Attic
- ❑ Heat Loss in Attic

- ❑ Build-up of Ice + Snow at Soffit
- ❑ Melt Water Enters Attic Area
- ❑ Damage to Interior Finishes
